NO NAME 784

PHASE I INSPECTION REPORT  
NATIONAL DAM SAFETY PROGRAM

BLACK & VEATCH  
CONSULTING ENGINEERS  
KANSAS CITY, MISSOURI

Name of Dam	No Name 784 Dam
State Located	Missouri
County Located	Platte County
Stream	Tributary to Line Creek
Date of Inspection	31 August 1978

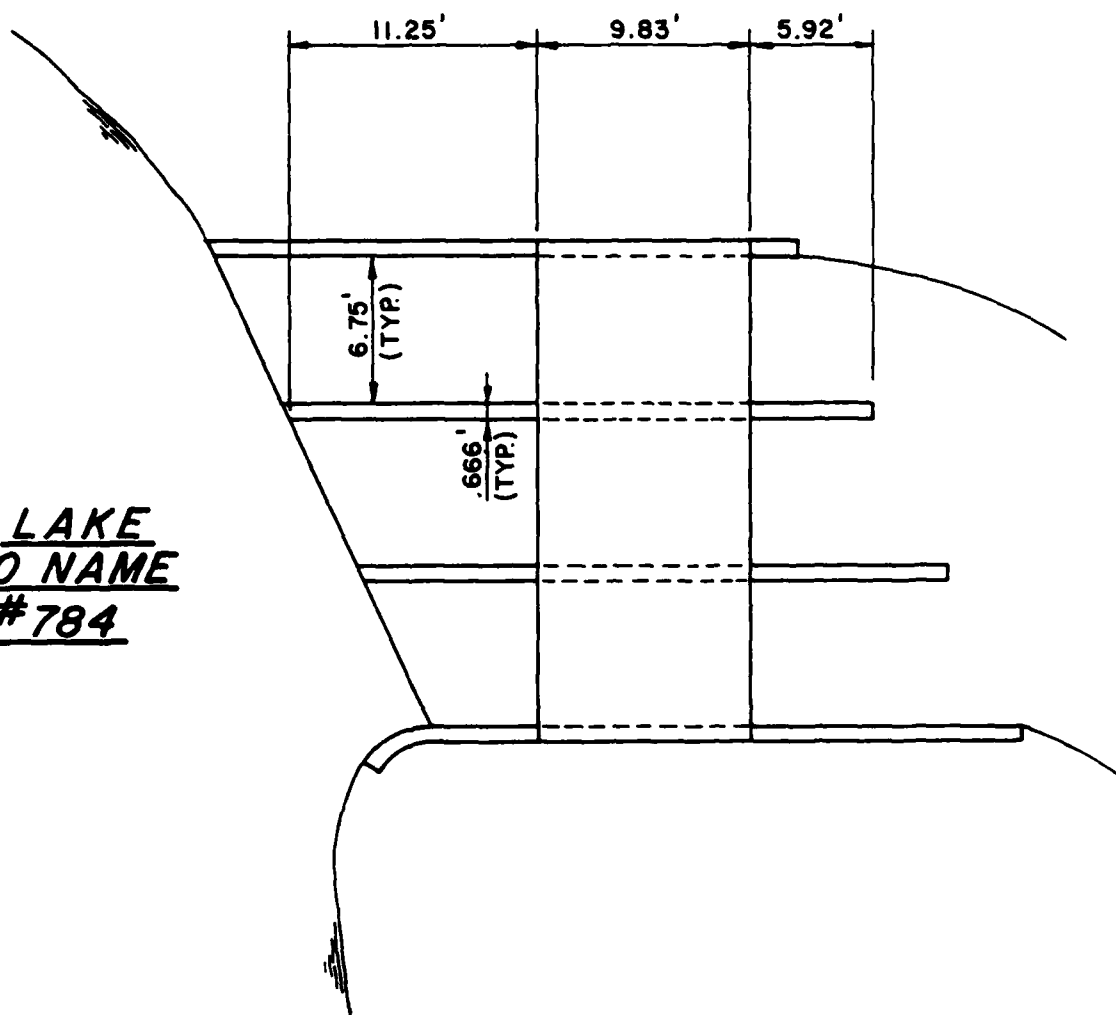
SCALE 1/8" = 1.0'  
NO NAME #784  
SPILLWAY

c. Appurtenant Structures. The spillway is a concrete broad-crested weir consisting of three 6.75-foot bays with a total weir length of 20.25 feet which spills into a concrete lined discharge channel. There is some minor cracking and spalling of the concrete in the walls and slab of the spillway. The concrete approach channel upstream of the spillway has cracked and been undermined near the right spillway wall. The concrete discharge channel has cracks which extend the full width of the channel at 20 feet and 45 feet downstream of the spillway. Erosion of material beneath the discharge channel is evident. Large rock has been dumped at the downstream end of the concrete discharge channel.
